# BUREAU OF SHIPS GROUP TECHNICAL INSPECTION REPORT

⑥ OPERATION CROSSROADS.  
U.S.S. WAINWRIGHT (DD 419)

TEST ABLE [U]

USS WAINWRIGHT (DD419)

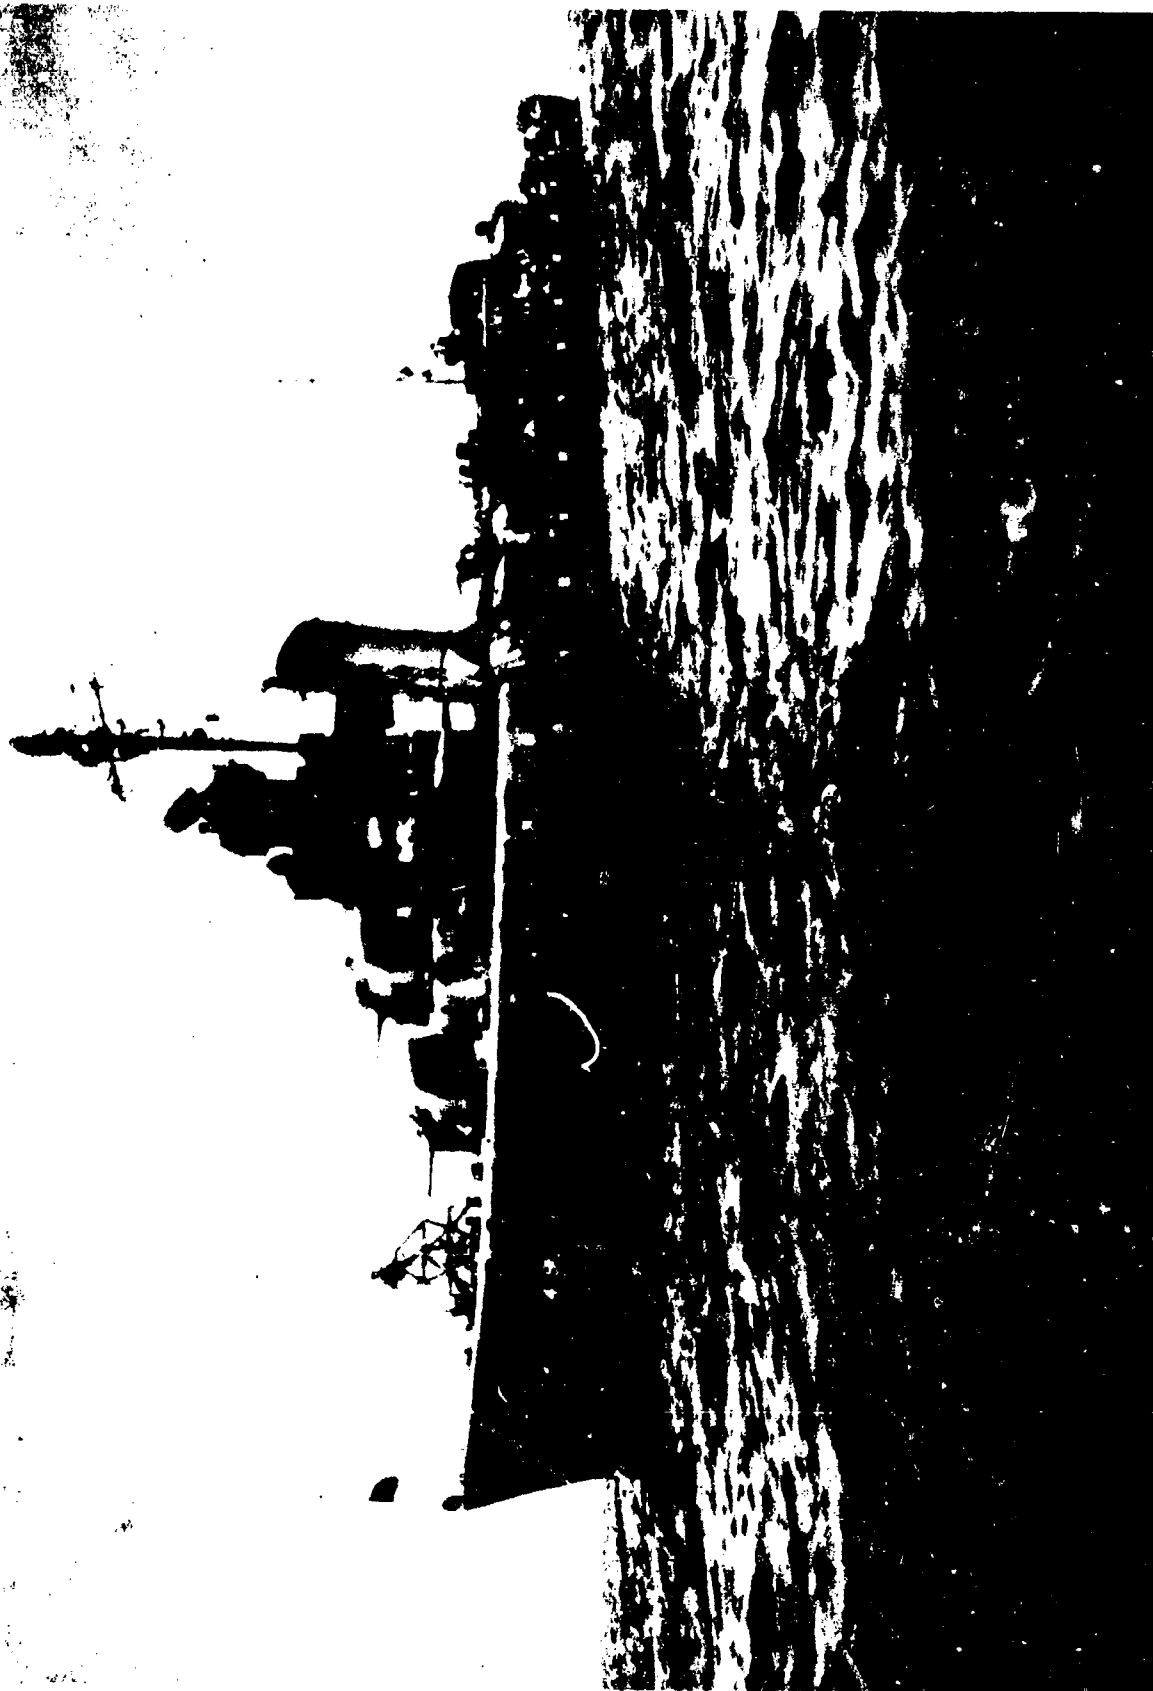
AA-CR-227-49-98. View from off port bow after Test A.
